# **PARIS MUSEUM OF PUBLIC WORKS – PALAIS D'ÉNA**

### **RESTORATION OF THE FACADES OF THE PALAIS D'ÉNA**

Project: Concrete restoration

Name: Palais d'Éna

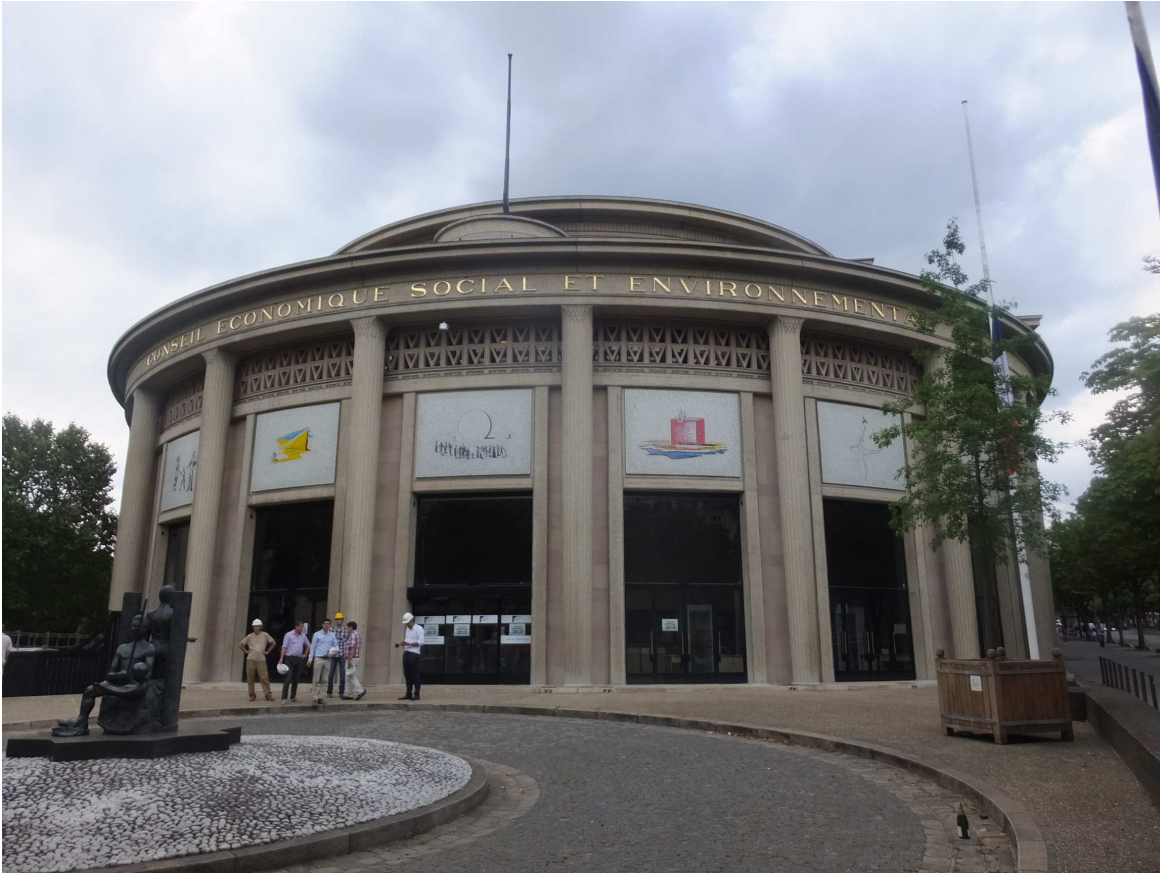
*(Picture 1)* Entrance rotunda after restoration work

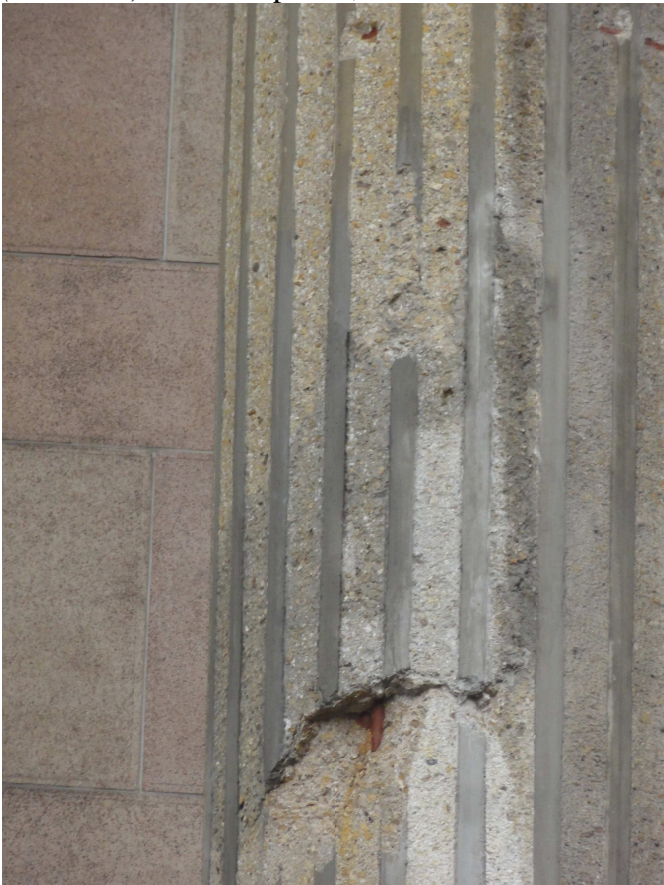
Despite a remarkable concrete quality, the facades required a durable restoration, to regain the original exceptional appearance. The columns were partly spalled and blackened. The bases were heavily decayed exposing the bars. Previous recent repairs had already burst. Pollution and rainwater had caused black crusts and calcite concretions.

*(Picture 2)* Column spalled, before restoration

The restoration company developed a specific protocol and phasing of the work to reproduce the hammered concrete. It consisted in removing the rust from the soft iron reinforcing bars, eliminating the decayed concrete beyond the reinforcement a little farther than usually in order to be able to pour the newly formulated concrete, to fix formworks to the scaffolding, to pour the concrete with a few centimeters extra thickness from the surface, to stop for a few weeks waiting for the concrete setting and finally to hammer it. For the raw concrete specific formworks were used to reproduce the original board marks.

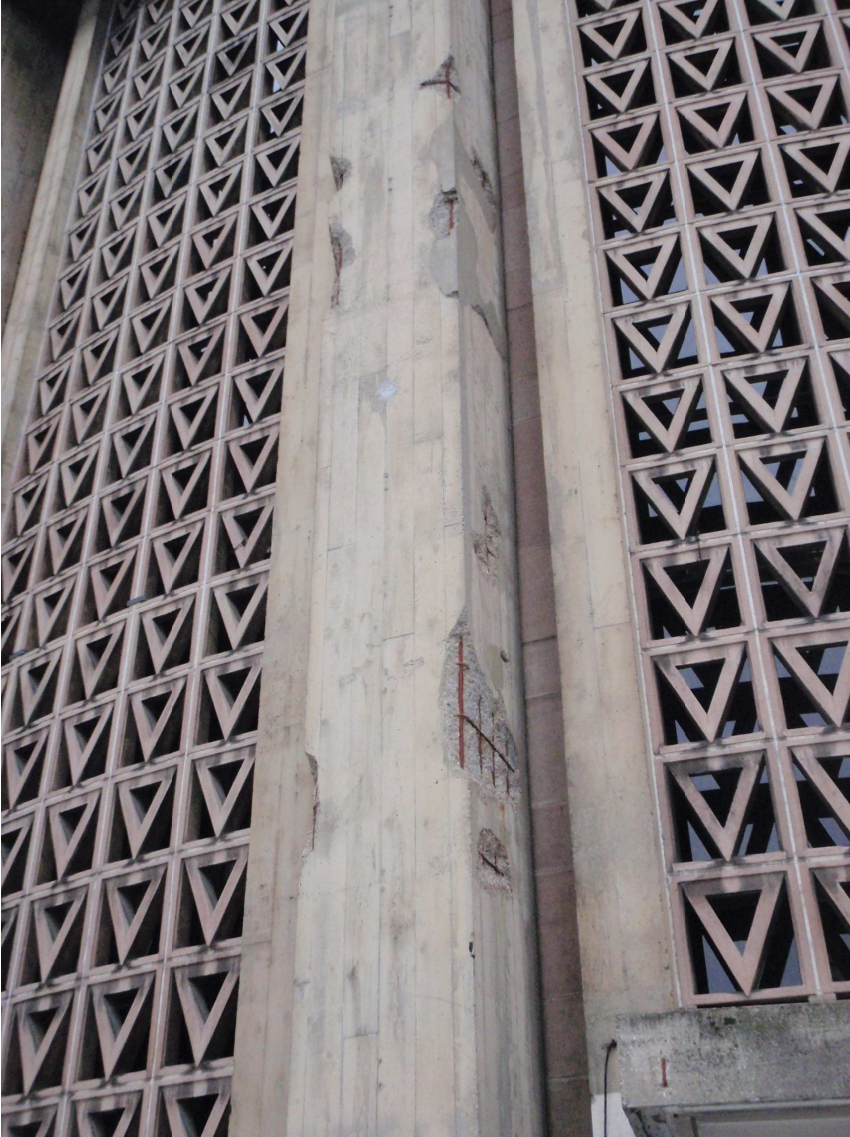
(Picture 3) Pilar spalled and previously repaired, before restoration

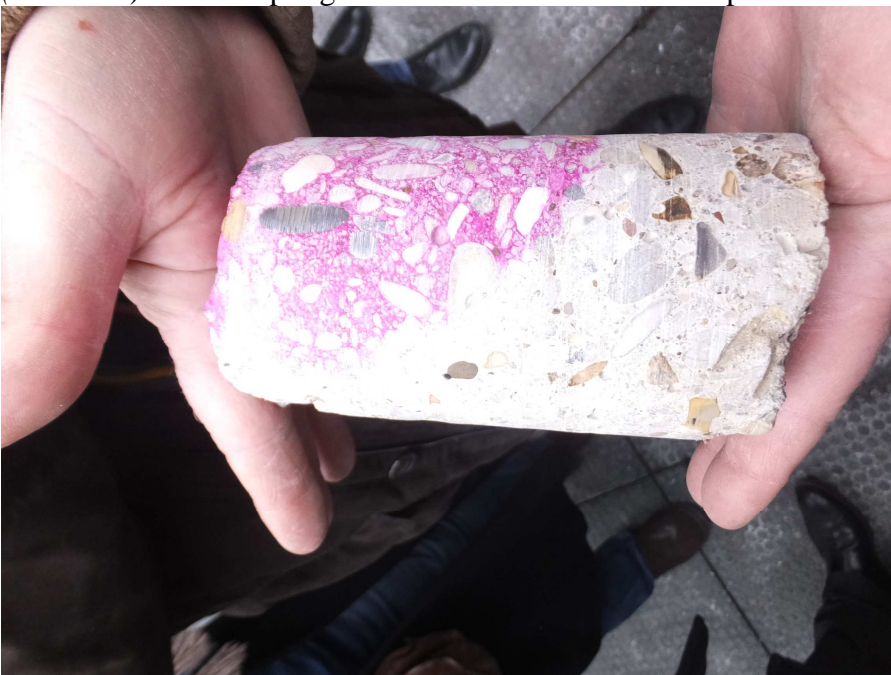
A meticulous record of the 300 meters of façades details and apparent alteration was performed and rectified photographs were taken. The laboratory diagnosis revealed that the concrete was quite homogeneous, with a good compactness, but a great disparity of the concrete covers. So that the carbonation depth of the concrete, even if quite limited for a monument of that period (20 to 30 mm), had reached the less covered bars, inducing their corrosion. Exogenous sulfate pollution due to the urban environment was also observed.

(Picture 4) Core sampling to evaluate the carbonation depth

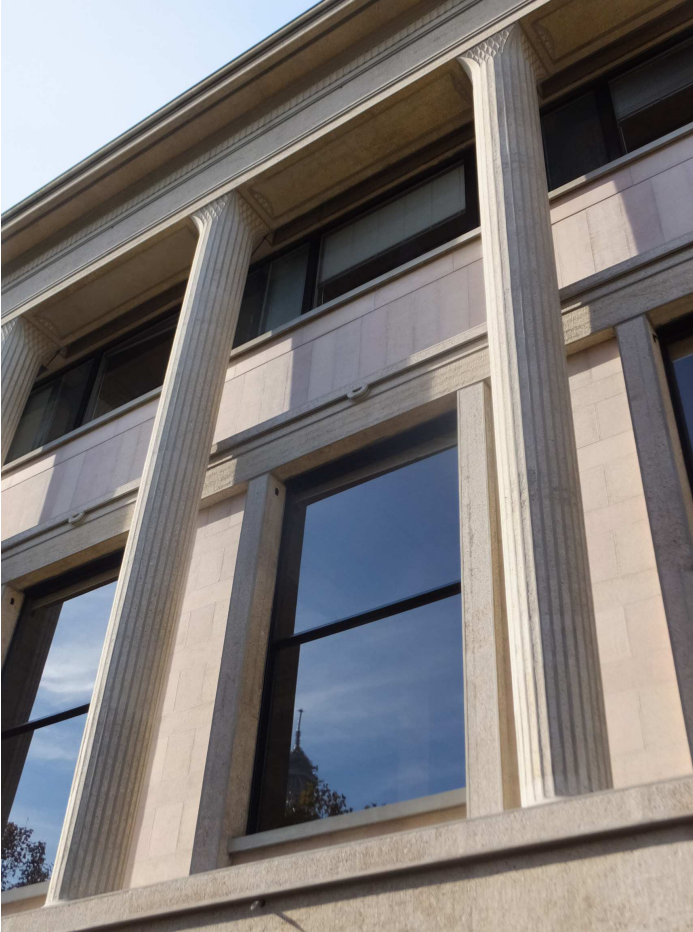
*(Picture 5)* Column, after restoration

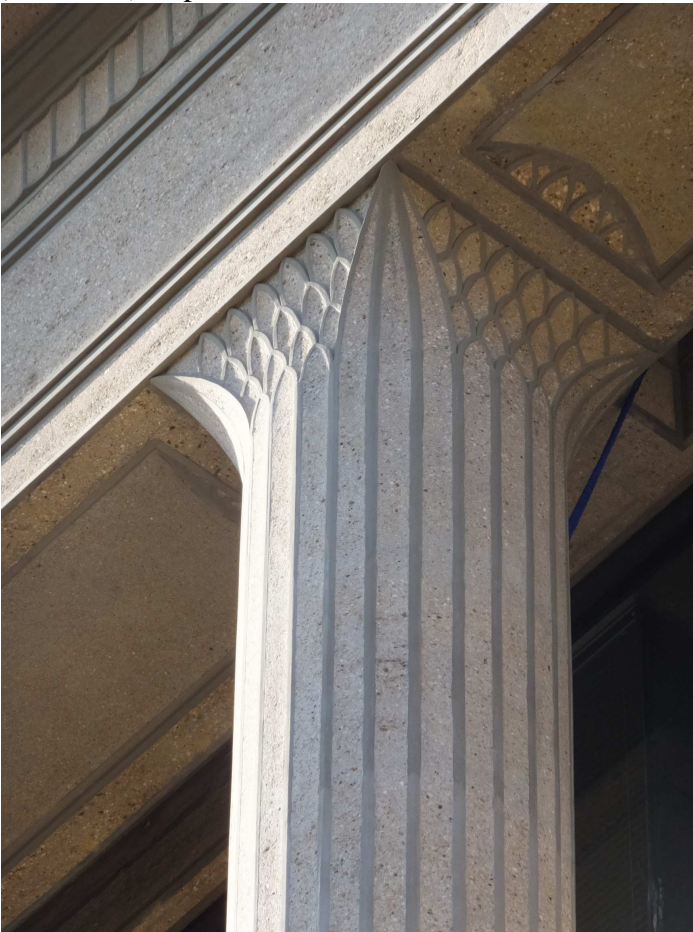
*(Picture 6)* Capital, after restoration

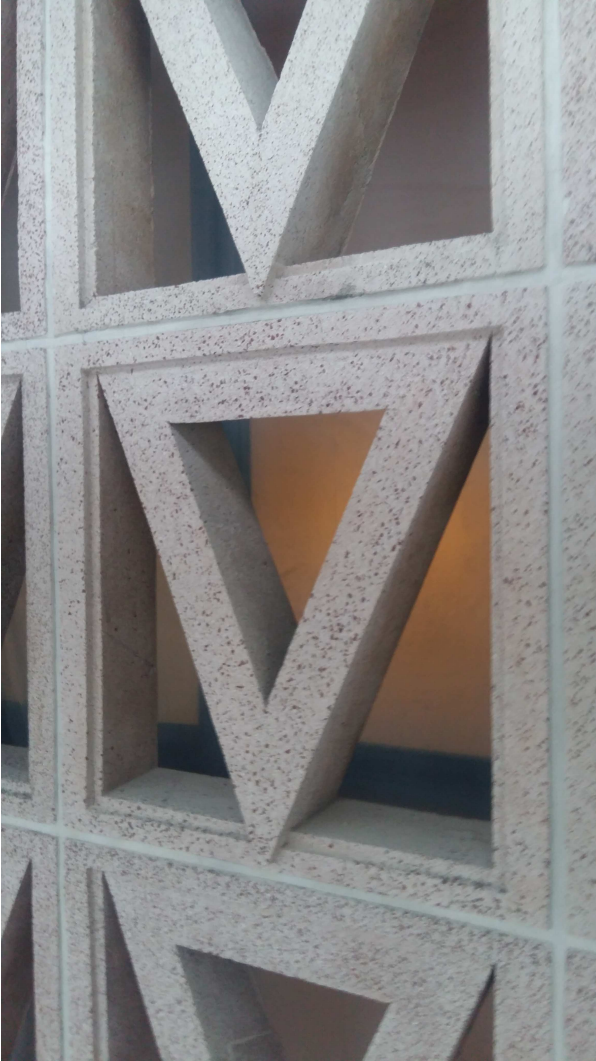
(Picture 7) Claustra, after restoration

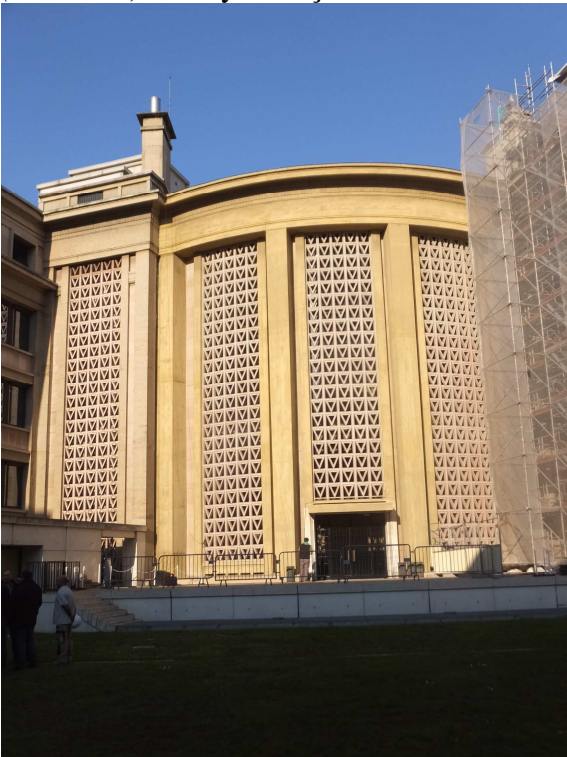
(Picture 8) Courtyard façade after restoration and restitution of the ochre wash

Finally, remains of an ochre-yellow wash made of natural earth and cement that covered the entire structure were discovered. For the first time, the wash was restituted according to the wish of Auguste Perret, to make the concrete, that he highlighted the qualities, less austere.
